Manhole Inspection Summary

Manhole # S13II_024MH

Insp Date: **9/18/07 12:22 PM**

Location Address: **1716 POPLAR GROVE ST**

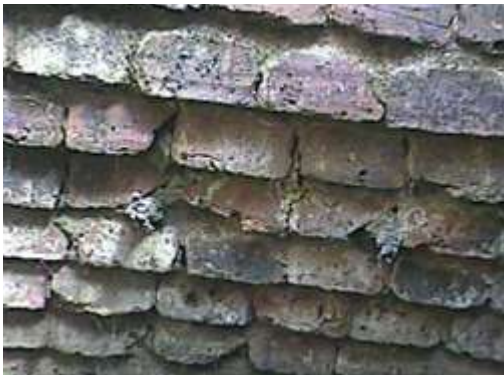
Defect 1

Count: **2** Missing: **2** ☒ **Corroded**

MISSING/CORRODED RUNGS

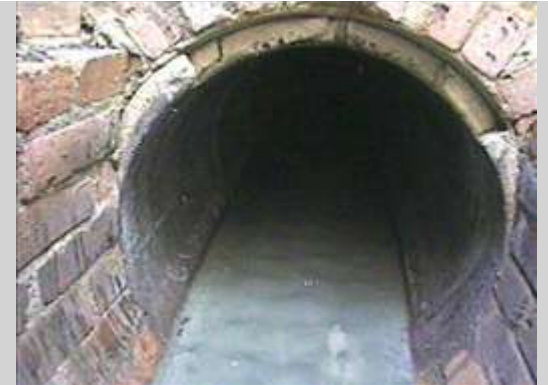
12 O'Clock Outflow

18 in. Circular Gravity Sewer
Pipe Out @ 12 O'Clock

Pipe Height: (in.) Direct
Pipe Material: **Clay** ☐ Pipe Lined
Invert Depth: **6.08** (ft.) Flow Characteristics: **Slow**
Deposits: ☒ None ☐ Mud ☐ Sludge ☐ Debris ☐ Grease
Silt Depth: (in.) Deposits Extent:
Infiltration: **None** Pipe Seal Cond: **Cracked**

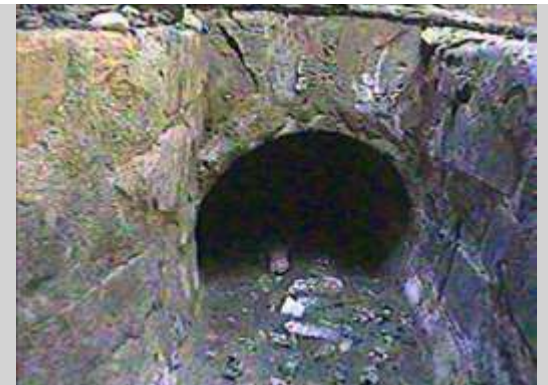
3 O'Clock Inflow

8 in. Circular Gravity Sewer
Pipe In @ 3 O'Clock

Pipe Height: (in.) Direct
Pipe Material: **Clay** ☐ Pipe Lined
Invert Depth: **5.60** (ft.) Flow Characteristics: **None**
Deposits: ☐ None ☐ Mud ☐ Sludge ☒ **Debris** ☐ Grease
Silt Depth: **2** (in.) Deposits Extent: **Light**
Infiltration: **None** Pipe Seal Cond: **Broken**

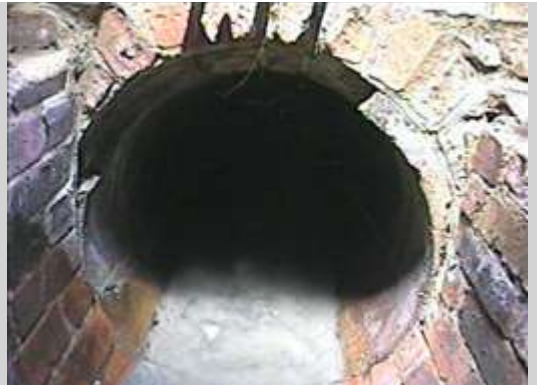
6 O'Clock Inflow

18 in. Circular Gravity Sewer
Pipe In @ 6 O'Clock

Infiltration: **None** Pipe Seal Cond: **Broken**
